The Fire Resistance Performance Of A Loadbearing Wall Assembly, In Accordance With BS 476: Part 21: 1987: Clause 8.

372077

Eurosips Ltd
Unit 42 Burnt Mills
Industrial estate
Harlow
Essex
CM20 2HU

16th December 2016

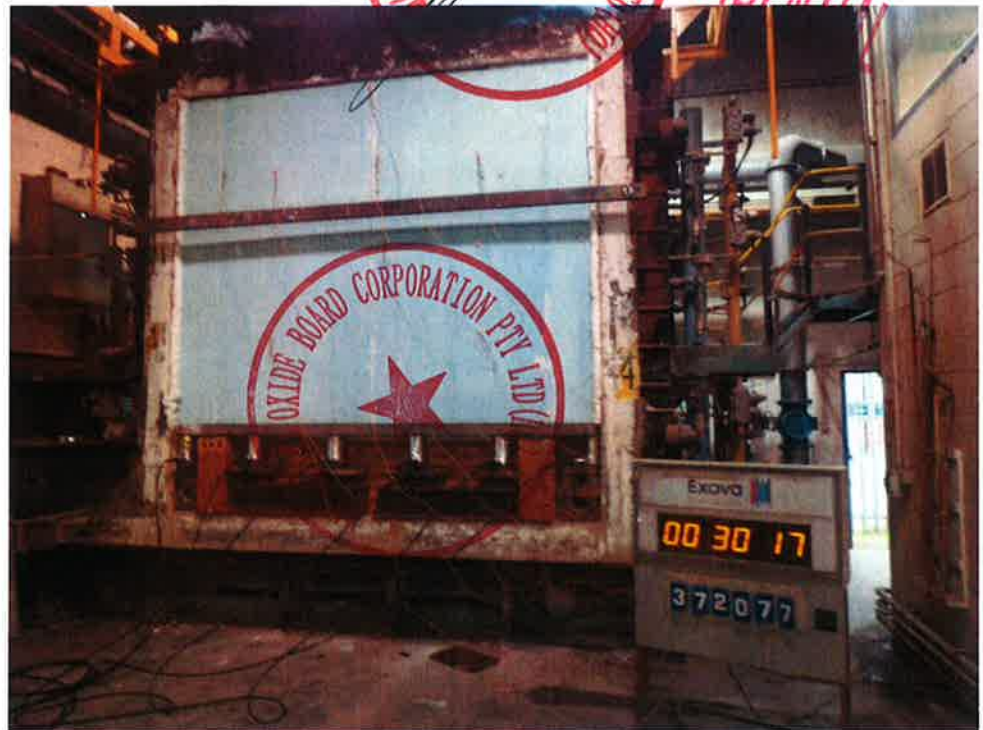
The unexposed face of the specimen after a test duration of 30 minutes

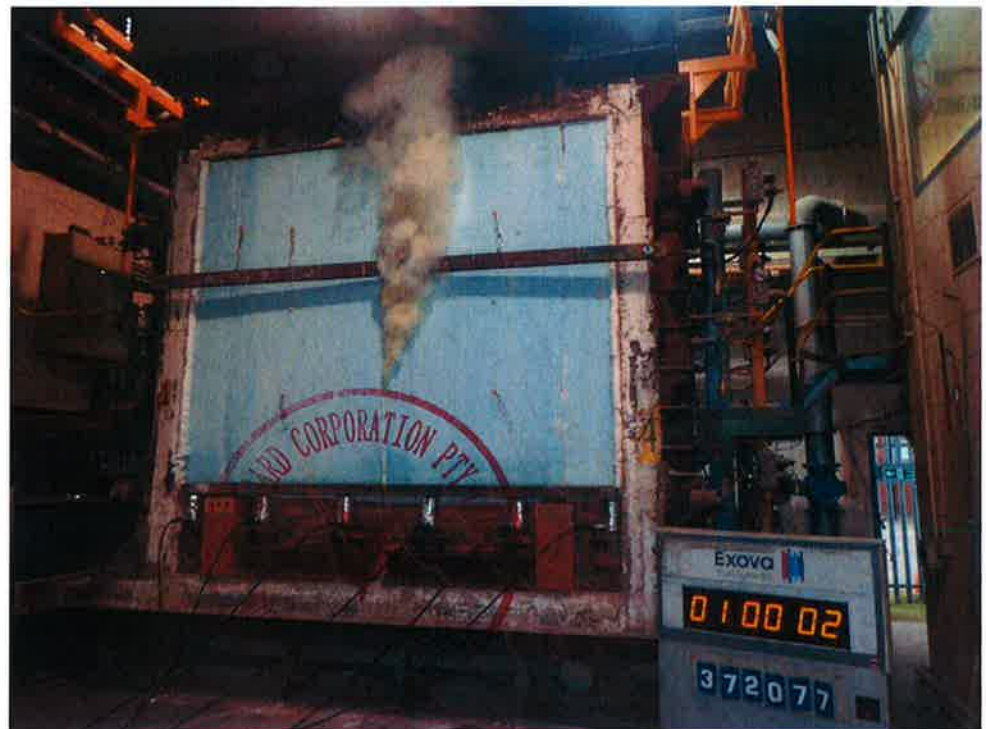
The unexposed face of the specimen after a test duration of 60 minutes

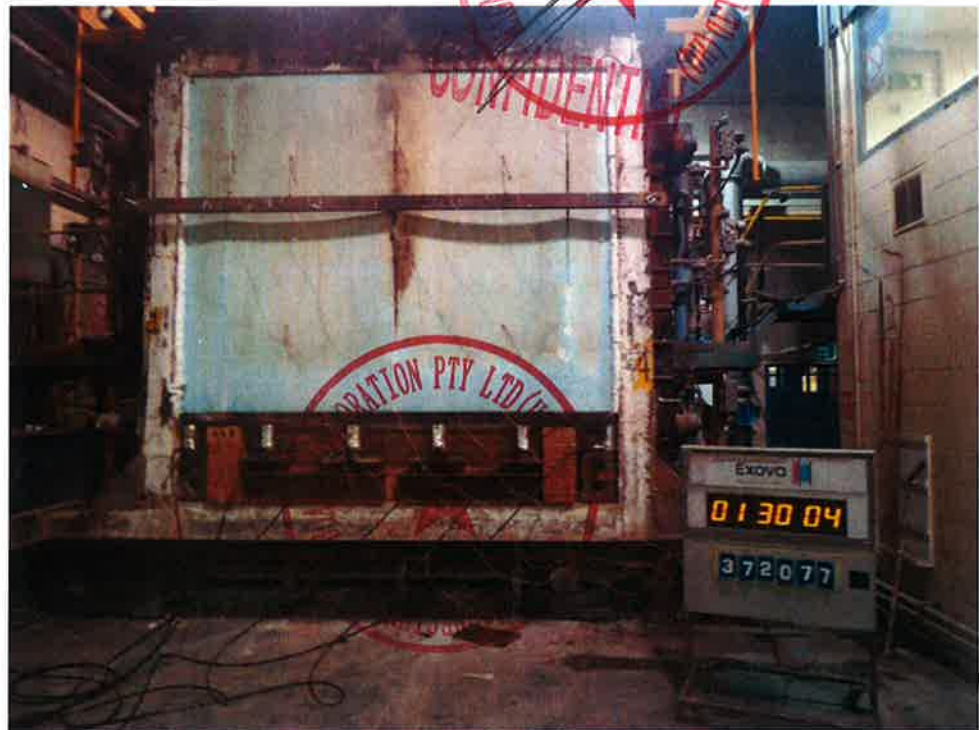
The unexposed face of the specimen after a test duration of 90 minutes

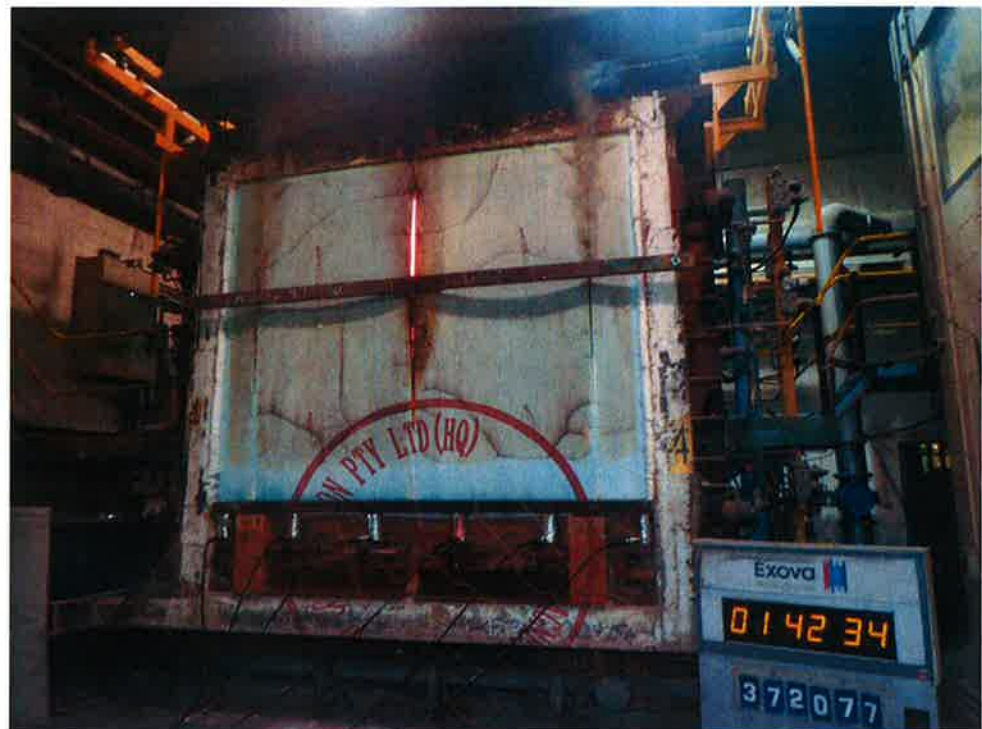
80	45	When viewed from the exposed face, the surface of the assembly radiates a bright orange colour. Large amount of flaming continues along the vertical joints in the boards. The assembly appears heavily distorted along the vertical joints also.
84	40	Smoke release has reduced along the central joint.
90	00	No visible significant change. The specimen continues to maintain its loadbearing capacity and satisfy the integrity criteria of the test. Approximately 90% of the surface of the assembly has discoloured a light brown colour.
99	30	Smoke release appears to have increased slightly along with discolouration at mid height of the outer vertical joints.
101	00	Flashes of flames issue along the bottom half of the central joint.
102	15	The central joint opens up very quickly and sustained flames issue along the joint. Integrity failure is deemed to occur. The test is discontinued.

The unexposed face of the specimen after a test duration of 102 minutes

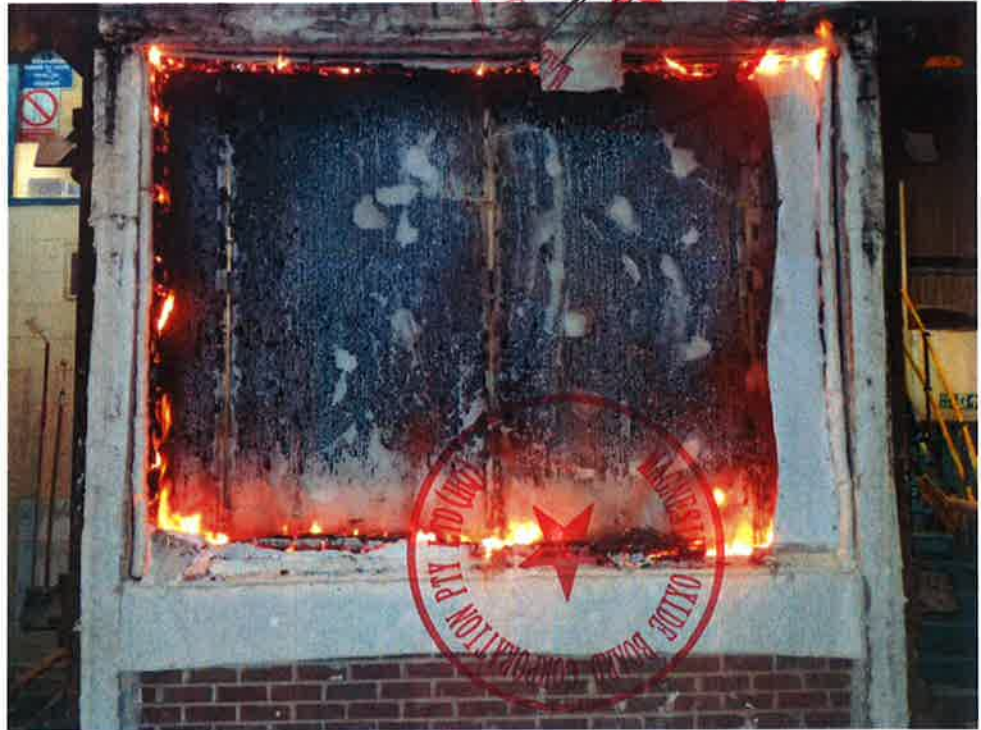
The exposed face
of the specimen
immediately after
the test
