## Test Report – Fire Resistance:

**SUBJECT:** R&D Investigation into the performance of ROBUST SYSTEMS by ResCom (CMC) Exterior and Interior Fire and Impact System.

**SCOPE:** Measurement of fire resistance in general accordance with AS1530.4:2014 Section 2.

**REPORT NUMBER:** **RTL FT 1361.01**

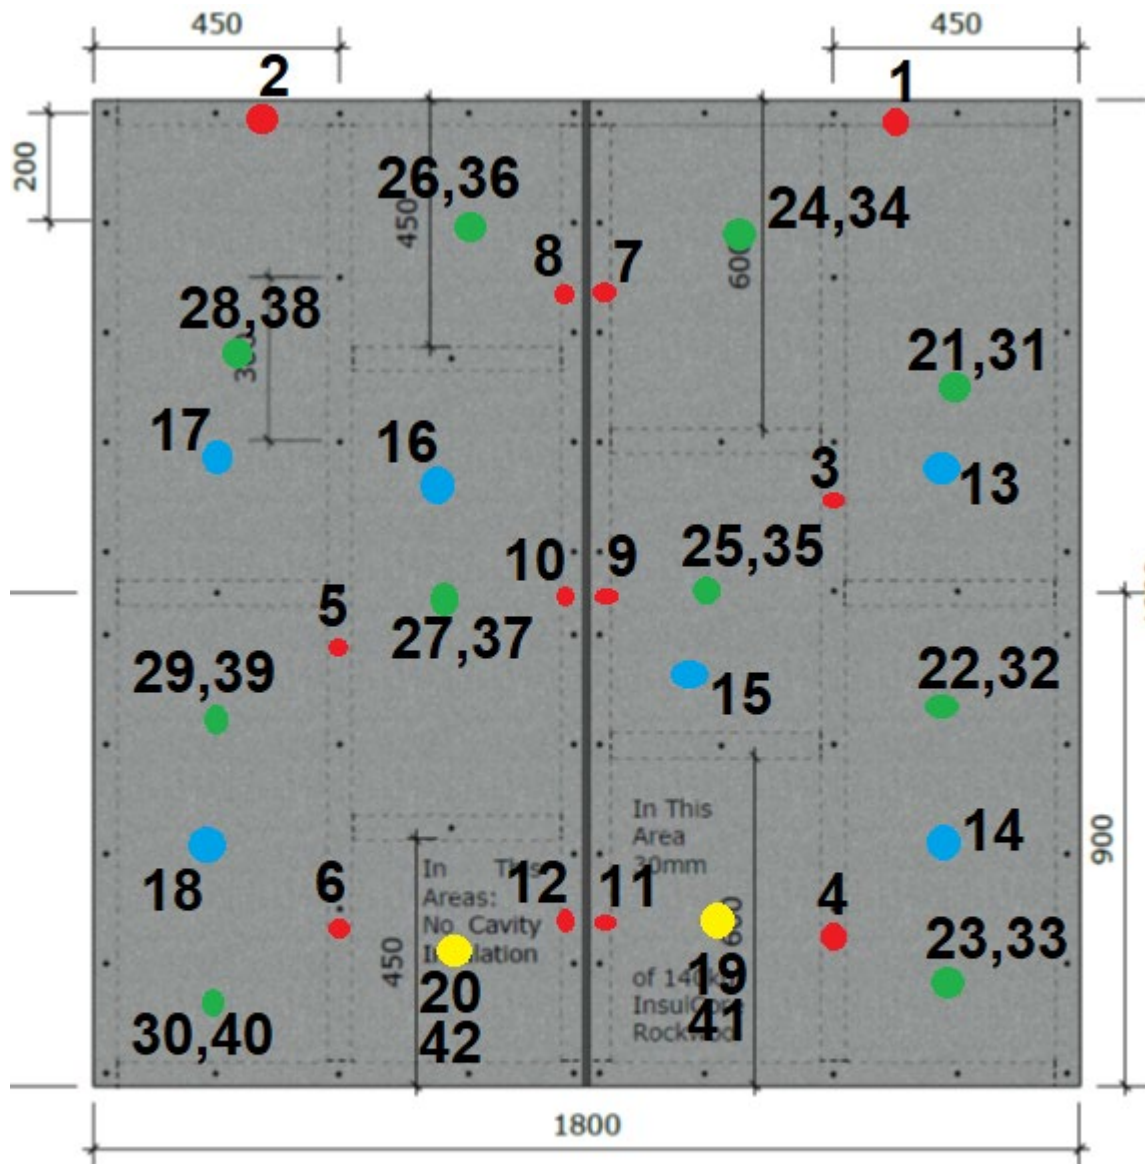
Figure 1 – Thermocouple Locations

- RED:** Outer face plasterboard = Thermocouples on the stud 25mm off the joint
- GREEN:** Thermocouples Both Sides of Plasterboard
- YELLOW:** Thermocouples Both Sides of Plasterboard
- BLUE:** Thermocouple located on the Fire Side of the Insulation behind the ResCom

Table 3 – Specimen Thermocouple Locations

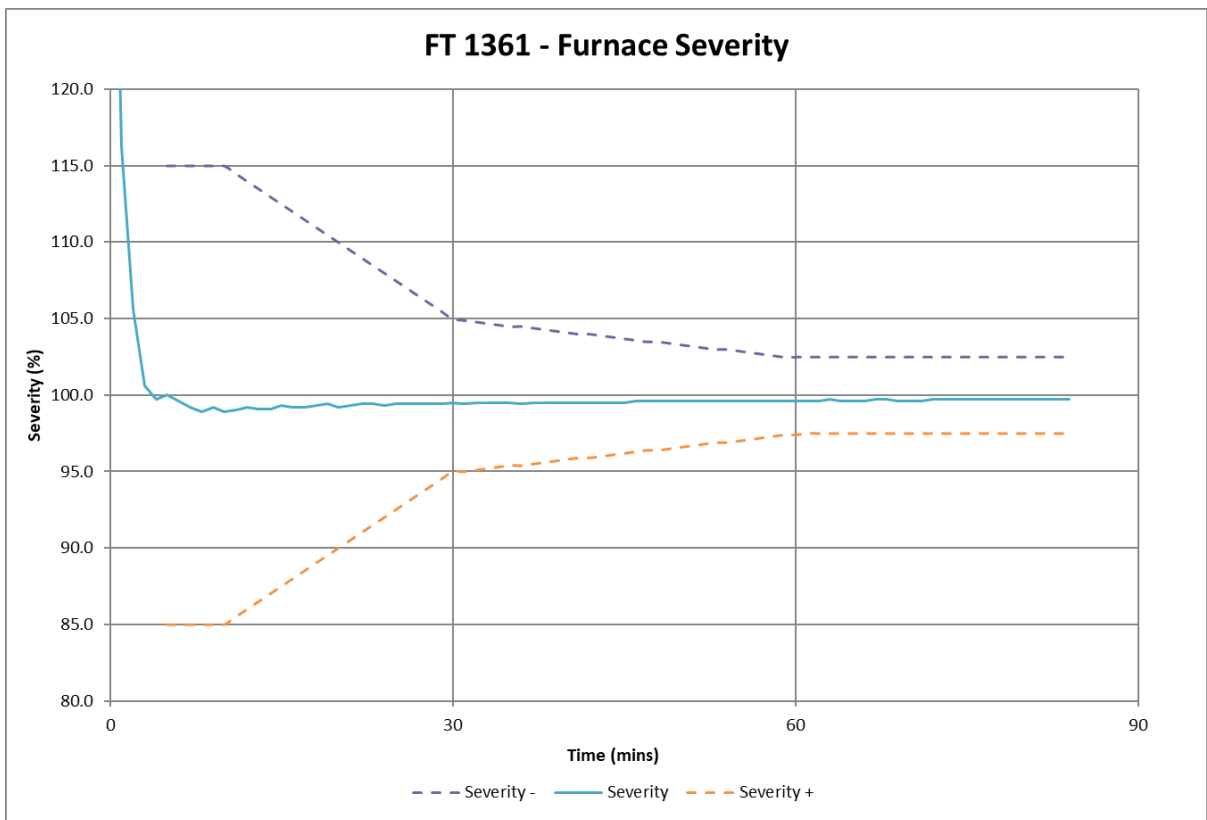
Chart 2 – Furnace Severity

Chart 2 shows the furnace severity versus time during the heating period.

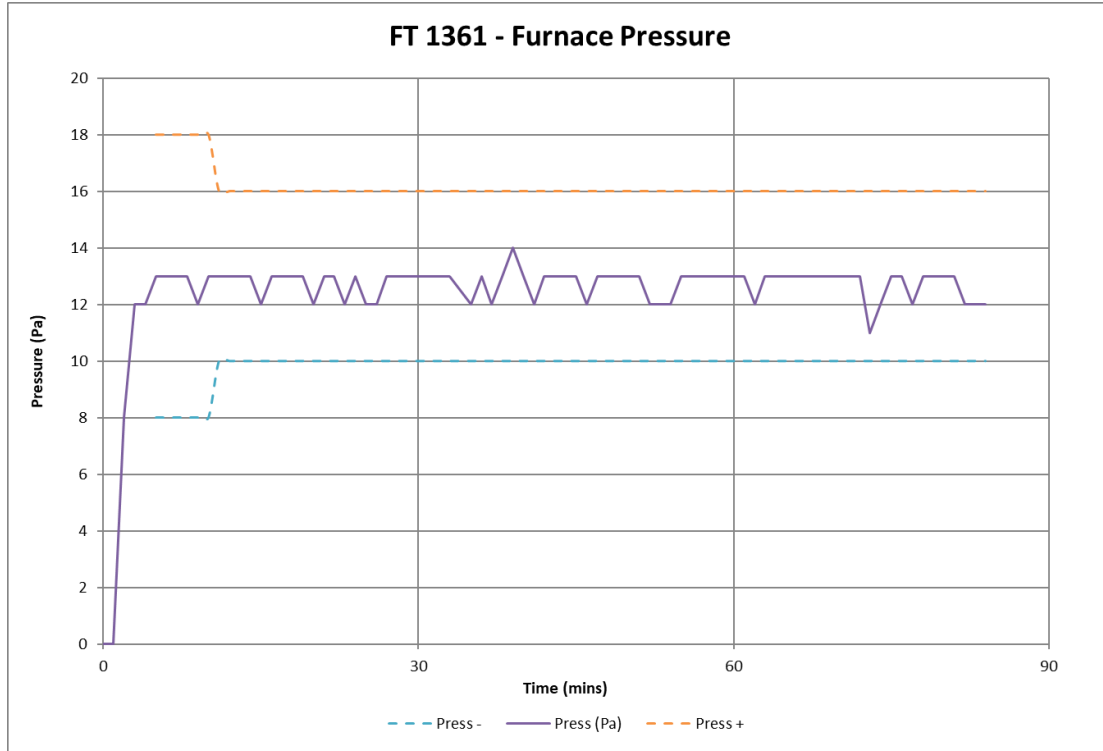
Chart 3 – Furnace Pressure

Chart 3 shows the plot of the furnace pressure versus time. The probe was located at 100 mm from the supporting construction. Furnace pressure differential was controlled in accordance with 2.11.3.1 of AS 1530.4:2014.

Note: Furnace pressure was controlled at the probe location at the mid height of the wall. The specimen was subjected to a target pressure of 20 Pa at the head of the wall.

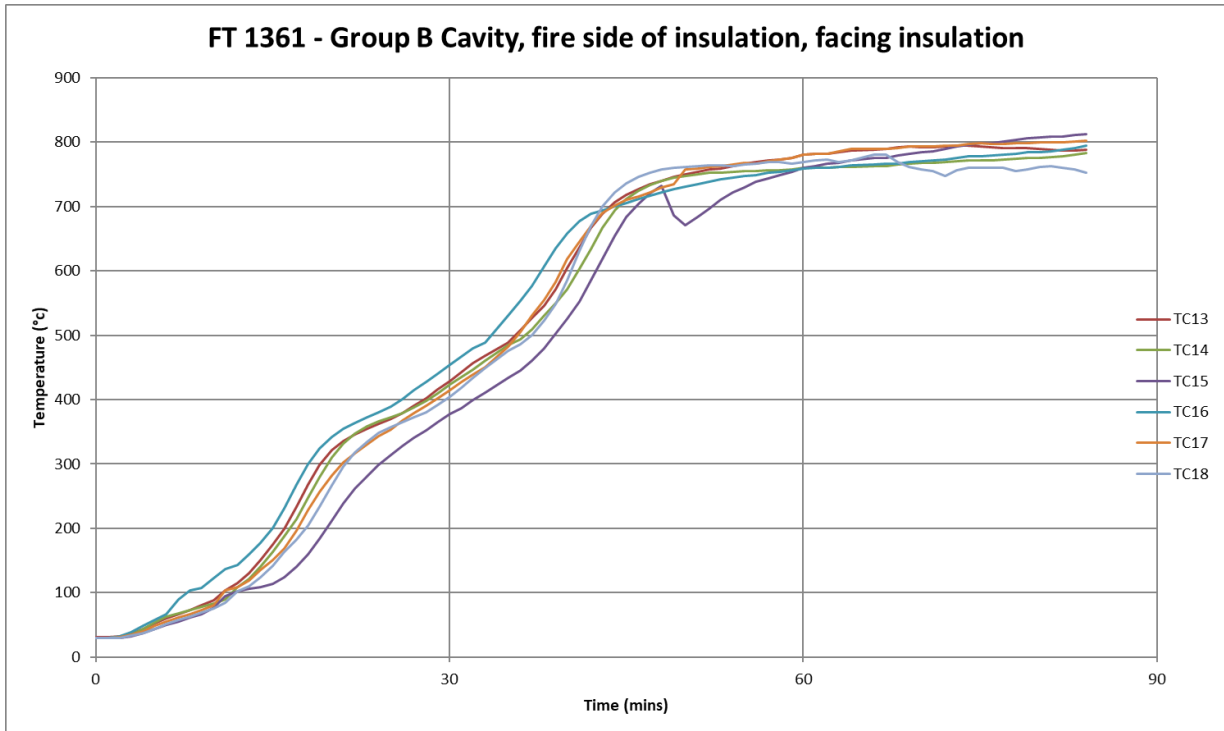
Chart 5 - Group B Cavity, fire side of insulation, facing insulation

Table 5 – Group B TCs, Labeled Blue Thermocouple Located on the Fire Side of the Insulation Behind the ResCom

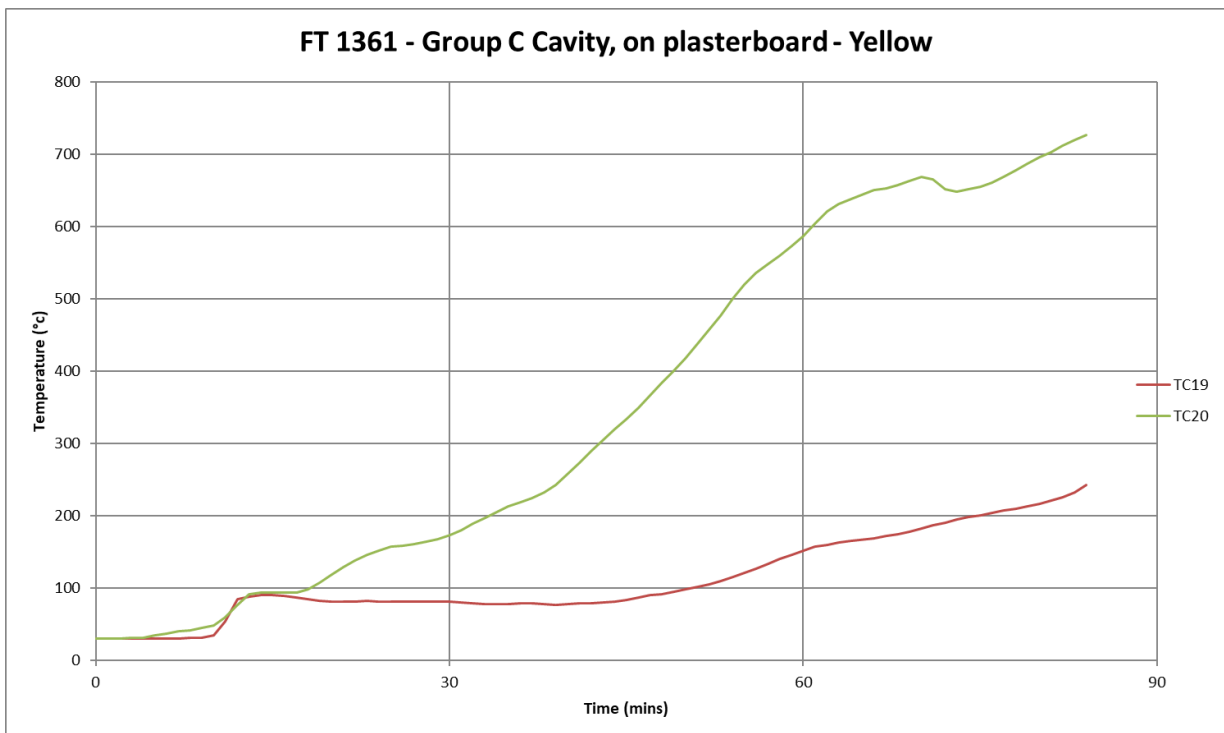
Chart 6 - Group C Cavity, on plasterboard - Yellow

Table 6 – Group C TCs, Labeled Yellow Thermocouples Both Sides of Plasterboard (Inside)

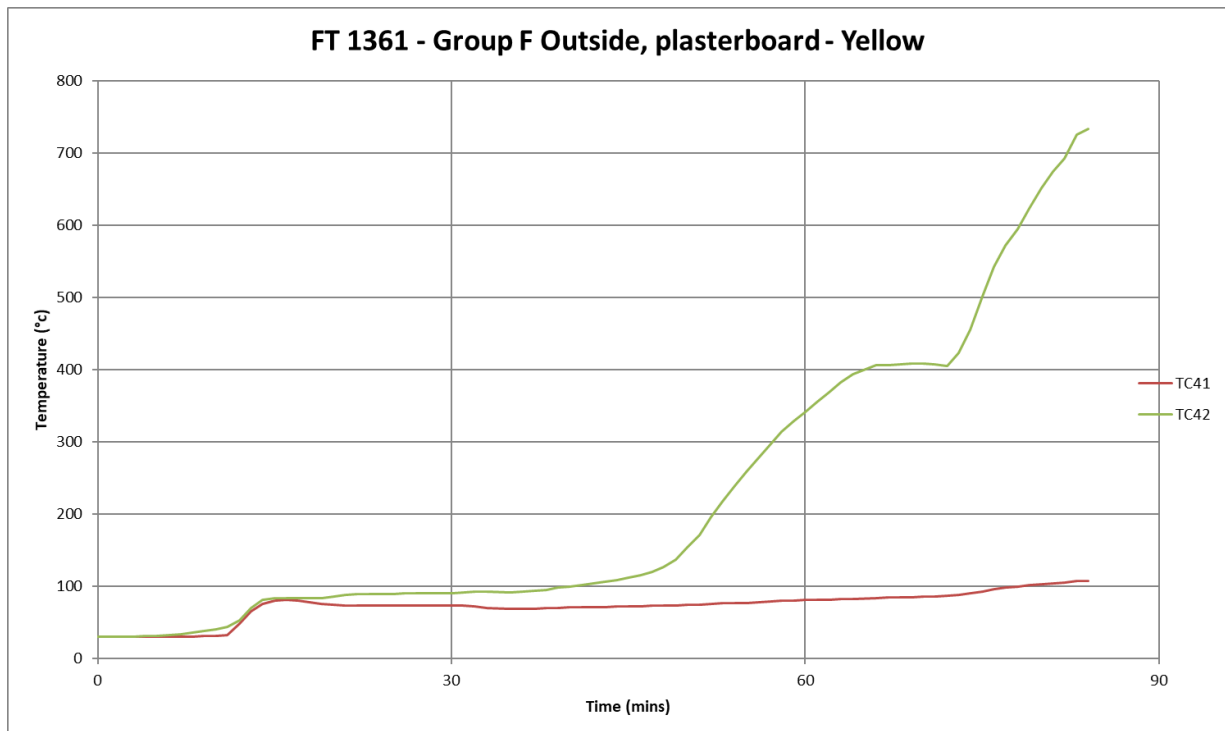
Chart 9 - Group F Outside, plasterboard - Yellow

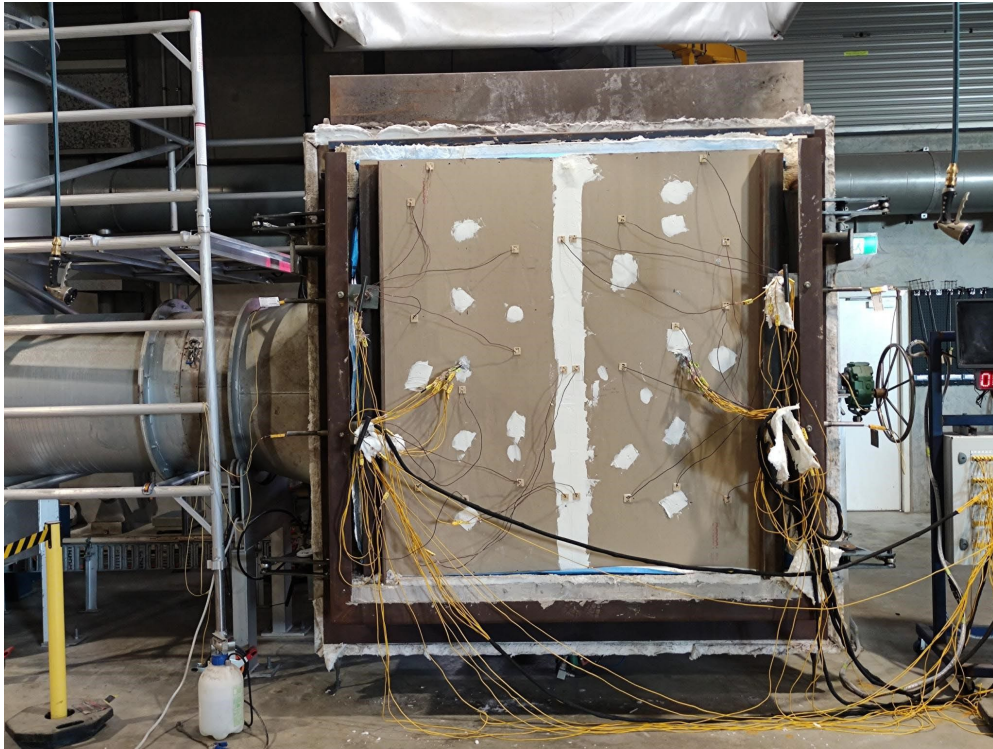
*Photo 1 - Non-fire side before test*
