# MAGNESIUM OXIDE BOARD CORPORATION PTY LTD TEST REPORT

BS476-22 (1987) TESTING ON RESCOM WALL SYSTEM, MODEL OF 10 MM MGO BOARD

180516006SHF-BP-1

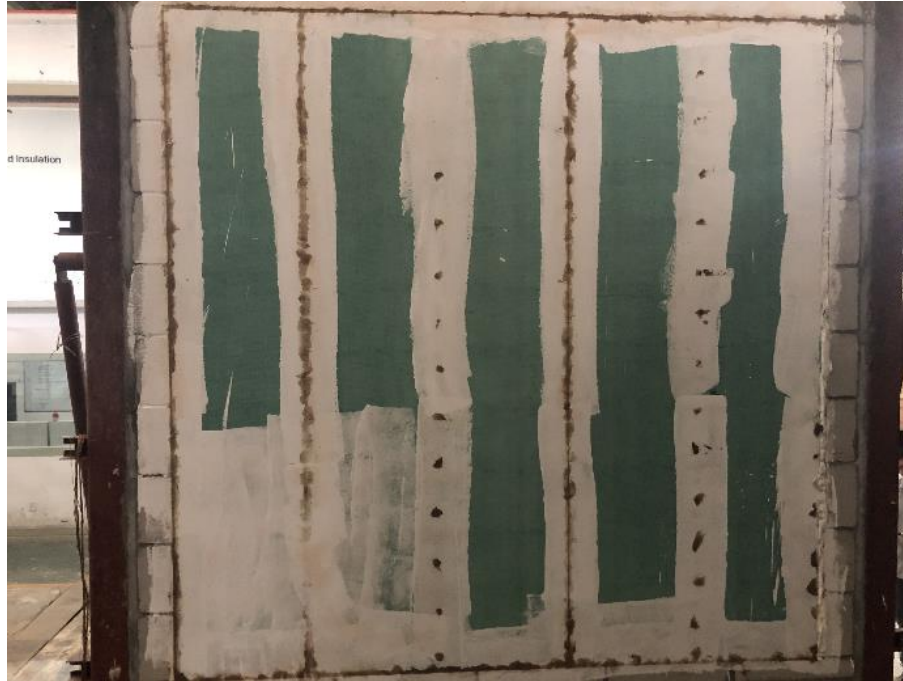
**Photo No. 1**  
**Exposed Side Prior to the Fire Test**

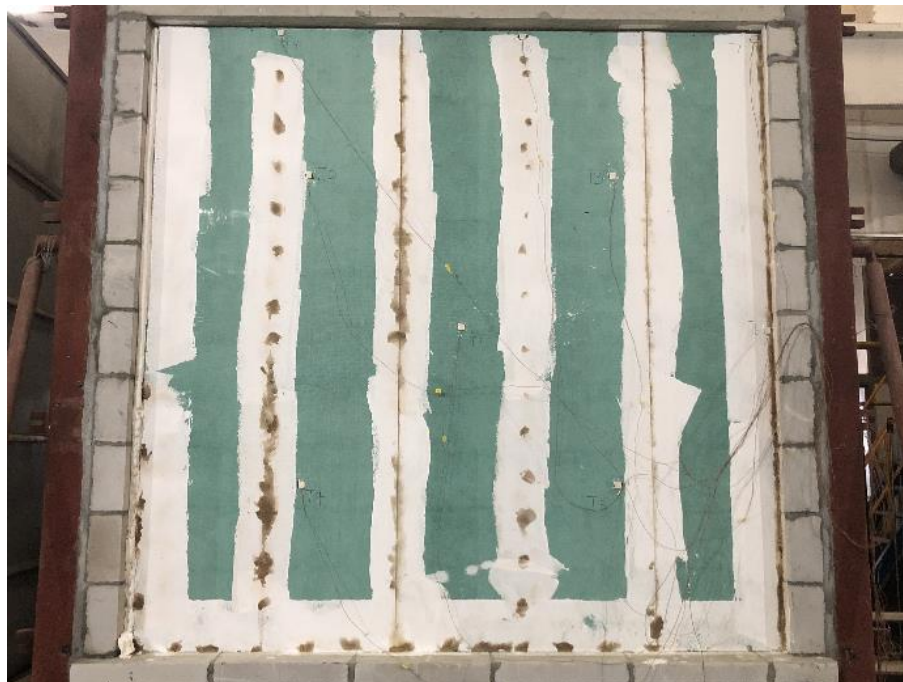
**Photo No. 2**  
**Unexposed Side Prior to the Fire Test**

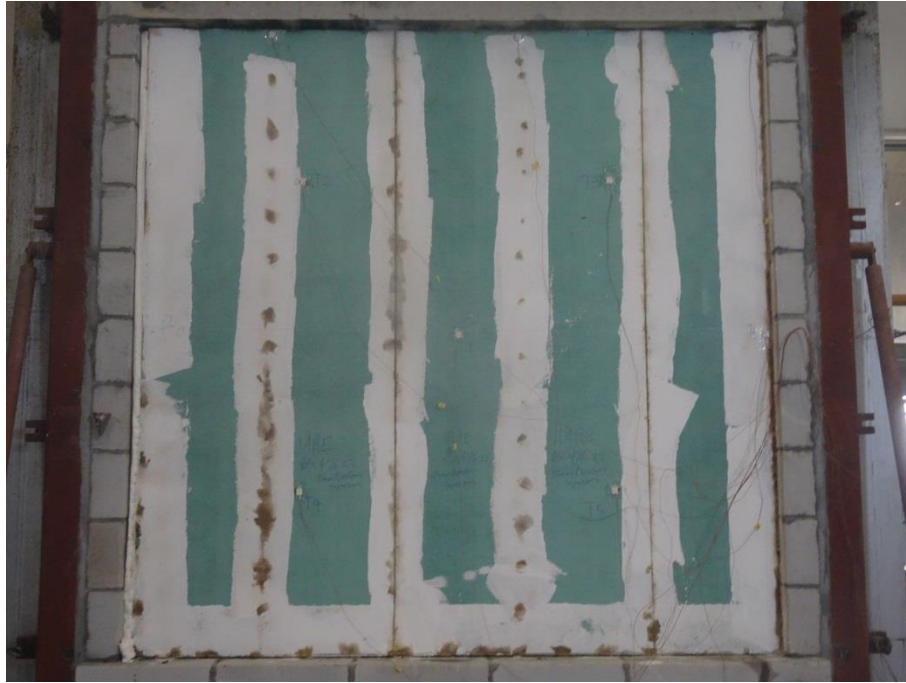
**Photo No. 3**  
**Unexposed Side after 31 Minutes**

Time		All observations are from the unexposed face unless noted otherwise.
Mins	Secs	
00	00	Test starts.
04	33	Smoke issues from top edge of wall system.
25	00	No significant change.
27	53	Light smoke issues from bottom edge of wall system. Crack on fire compound on panel joints is observed.
31	58	Light smoke issues from panel joints.
55	01	Discoloration on joints is observed.
59	30	A cotton pad is applied on 3/4 height of left joint, the pad is charred but not ignited.
84	20	A cotton pad is applied on 1/2 height of left joint, the pad is not ignited.
87	33	A cotton pad is applied on 1/3 height of right joint, the pad is not ignited.
98	50	6mm gauge can not be inserted into right joint.
113	03	A cotton pad is applied on 1/3 height of right joint, the pad is charred but not ignited.
118	31	A cotton pad is applied on 1/4 height of right joint, the pad is not ignited.
119	02	6mm gauge can be inserted into furnace but can not move for 150mm.

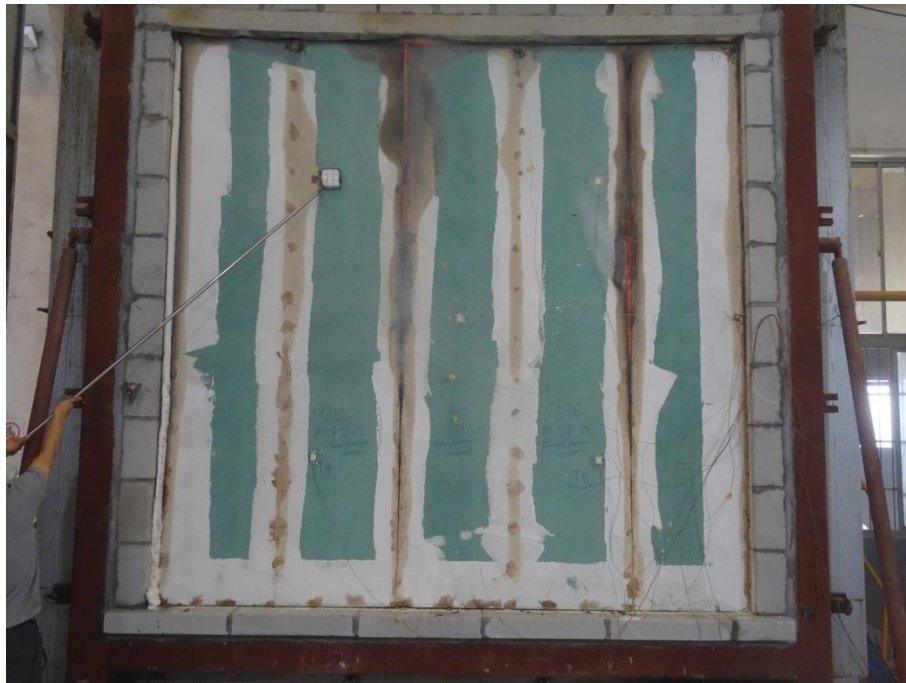
**Photo No. 4**  
**Unexposed Side after 102 Minutes**

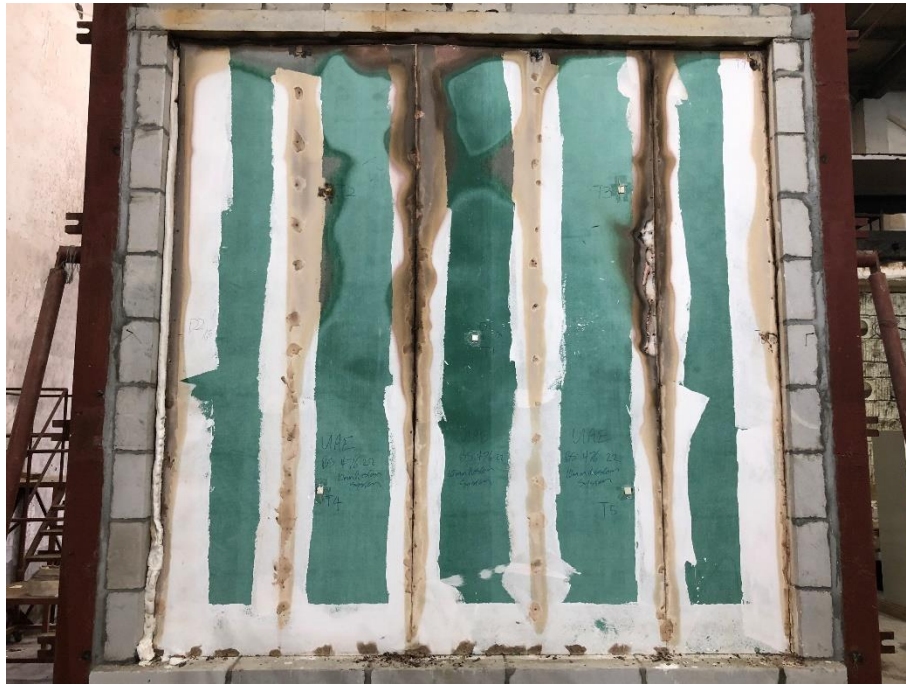
**Photo No. 5**  
**Unexposed Side after 120 Minutes**

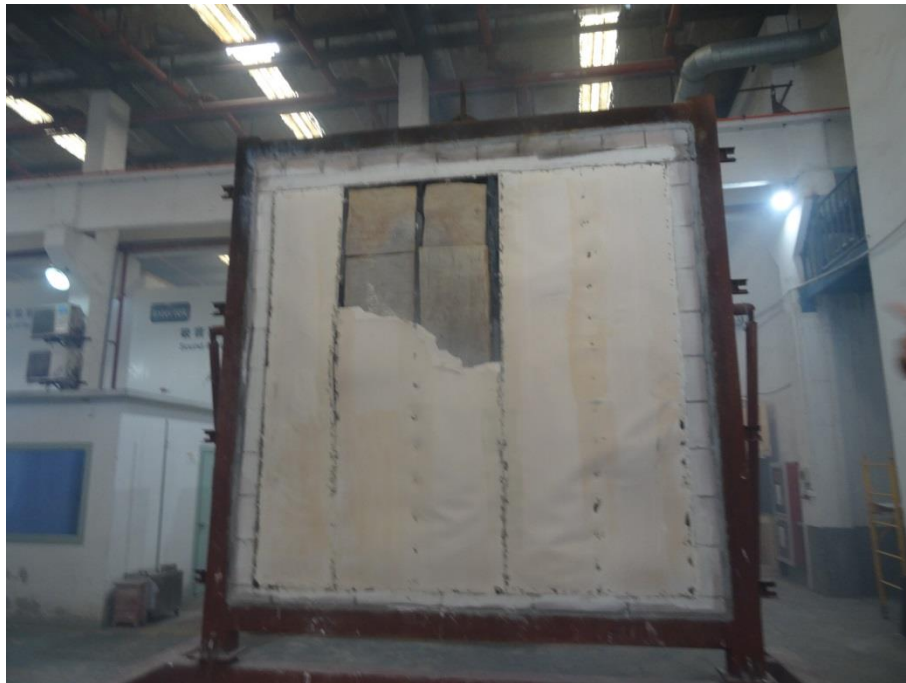
**Photo No. 6**  
**Exposed Side after 120 Minutes**
